SITE CLOSURE REPORT for SITE 4301.0 - LITTLE MOUNTAIN TEXT ANNEX DRAFT

Hill Air Force Base Ogden, Utah

SITE CLOSURE REPORT

SITE 4301.0 - LITTLE MOUNTAIN TEST ANNEX

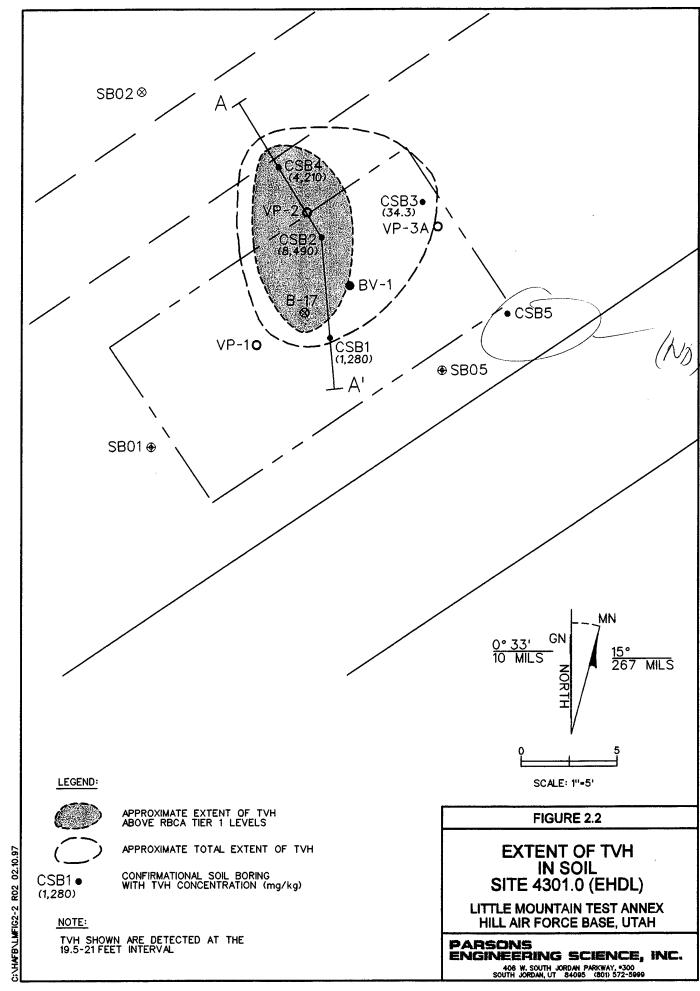
Soil analytical results are summarized in Table 2.1 and the laboratory data are contained in Appendix D. Replicate samples were collected from borings CSB3 and CSB5. Target analytes were not detected in an associated trip blank and equipment rinse blank (Appendix D). BTEXN and TVH constituents were almost exclusively detected at the 19.5- to 21-foot interval of the borings. The concentrations of all target analytes, except benzene, exceeded RBCA Tier 1 levels at this interval in soil borings CSB2 and CSB4 (Table 2.1). Although benzene was not detected above the reporting limits shown in Table 2.1, the limit of detection was higher than the RBCA Tier 1 level due to dilution. The TVH in CSB2 and CSB4 at this interval were 8,490 milligrams per kilogram (mg/kg) and 4,210 mg/kg, respectively. At CSB1, only naphthalene (13.9 mg/kg) exceeded its RBCA Tier 1 level (10 mg/kg) at this interval. The soil at the 19.5- to 21-feet depth is primarily an olive to greenish gray silt. The estimated areal extent of soils containing TVH at concentrations exceeding the RBCA Tier 1 level for soil is depicted in Figure 2.2. The vertical extent of TVH exceeding the RBCA Tier 1 level in soil is shown in geologic cross-section A-A' (Figure 2.3). Sand layers are present above and below the olive to greenish gray silt layer (Figure 2.3). Soil samples collected from these sand layers at the 14.5- to 16-feet and 24.5- to 26-feet intervals indicated the general absence of petroleum contamination (Figure 2.3 and Table 2.1). Based on the estimated dimensions of the remaining post-remediation soil contamination, approximately 4 cubic yards exceed RBCA Tier 1 levels. This volume is calculated assuming a cylindrical geometry for the contamination zone:

where the volume of a cylinder = $\pi r^2 h$, the average radius r is 3.75 feet, and height h is 2.5 feet (Figures 2.2 and 2.3).

The area of high total petroleum hydrocarbons (TPH) concentrations (7,500 to 30,000 mg/kg), based on the pre-remediation subsurface investigations, were within a five-foot-radius of the biovent well (Dames and Moore, 1994). Assuming a cylindrical zone of contamination and a height of five feet, approximately 15 cubic yards of soil were in excess of RBCA Tier 1 levels for the TPH gasoline range (1,500 mg/kg) at that time. Prior to bioventing, the total volume of soil impacted by the release was estimated to be 90 cubic yards (Dames and Moore, 1994). The post-remediation confirmational results indicate that the total volume of contaminated soil is significantly less, estimated to be as low as 11 cubic yards (cylindrical geometry with a 5.5-foot-radius and 3-foot-height). Therefore, the two years of bioventing were effective, particularly in the sand units adjacent to the silt layer.
